RAILROAD COMMISSION OF TEXAS

SURFACE MINING AND RECLAMATION DIVISION

RE: San Miguel Electric Coop, Inc.
San Miguel Mine, Permit No. 11G
Final Action Notification, NOV 114A

**Statement of Inspector's Observations
Notice of Violation No. 114A
Issued to San Miguel Electrical Cooperative, Inc.
San Miguel Mine, Permit No. 11G**

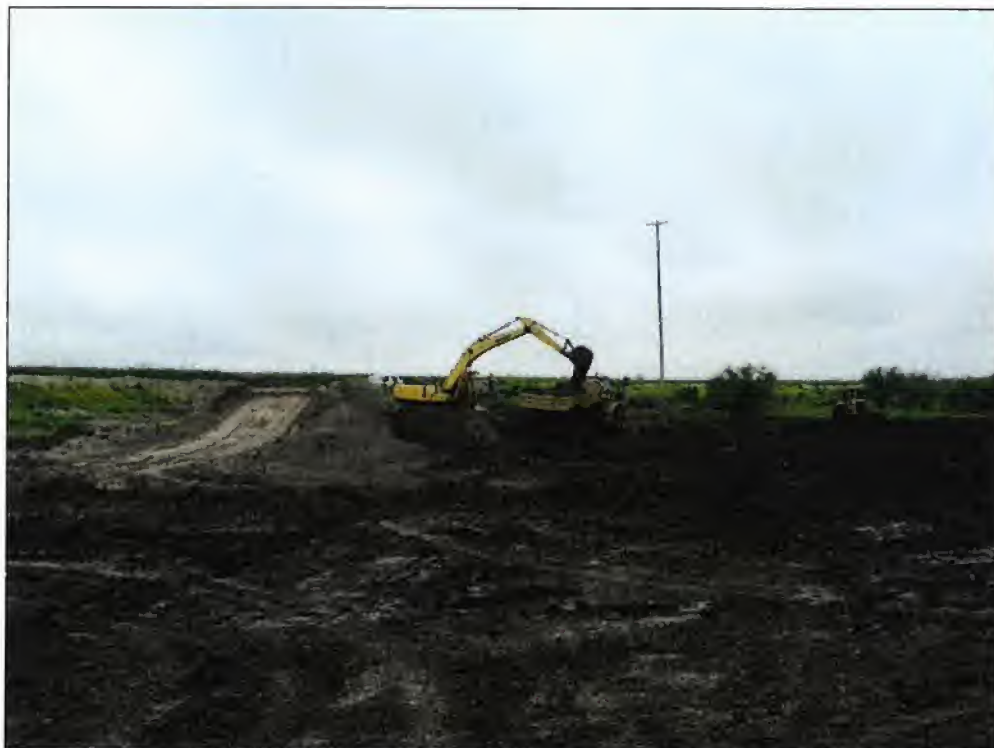
Photo 4. Equipment being utilized to remove sediment (view southwest).

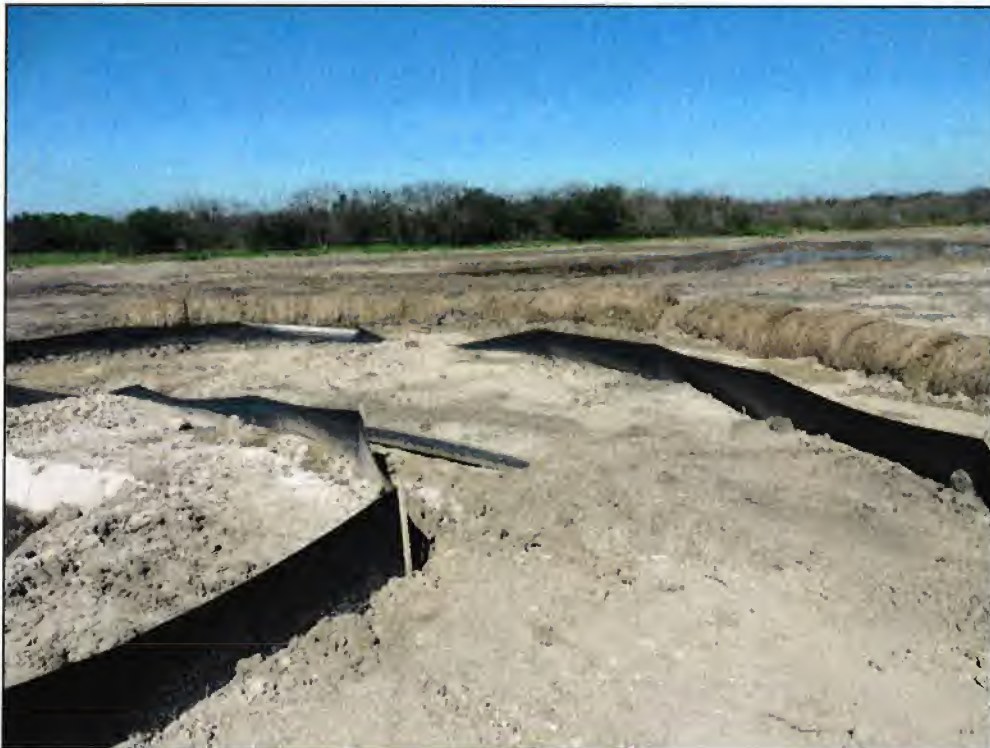
Photo 8. Silt fence and hay bales being utilized to prevent further sediment deposition (view northwest).

During my inspection on April 28-29, 2015, SMECI utilized silt fence and round hay bales to prevent further sediment deposition (photo 8). The round bales were trenched in place to prevent them from moving. The sump below Drop Structure No. BN-2 had been cleaned of debris and sediment. All sediment and vegetation was removed from the affected area (photo 9 and 10). In a follow up email with Nellie Frisbee dated May 7, 2015, all silt has been removed from the area and it was seeded for revegetation.

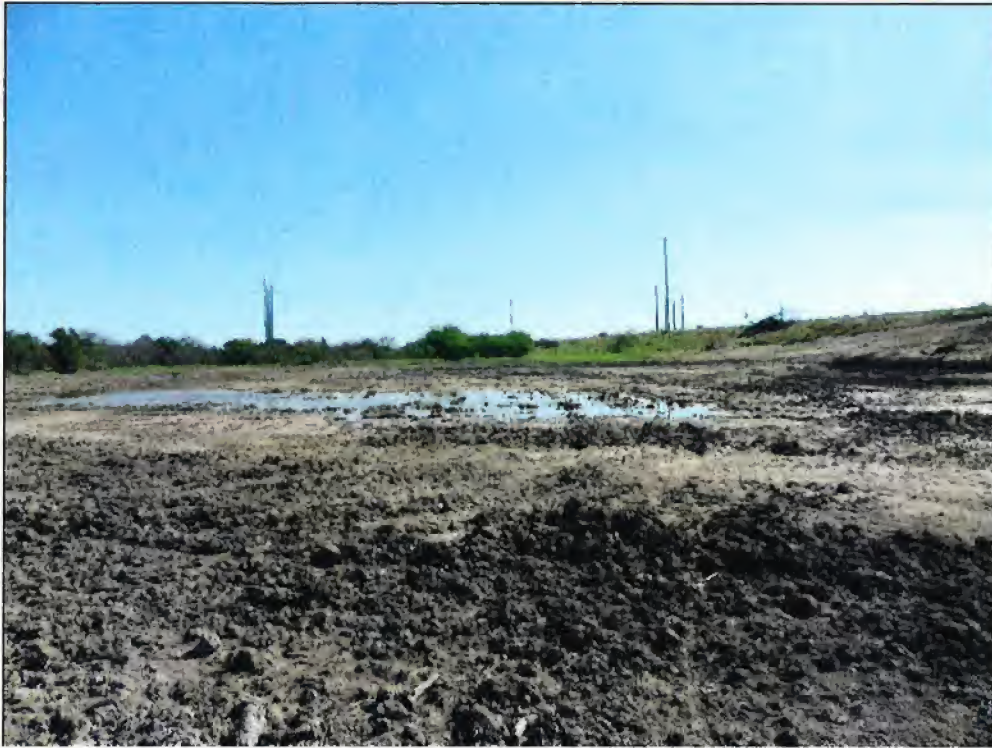
Photo 9. Sediment and vegetation has been removed from affected area (view northeast).

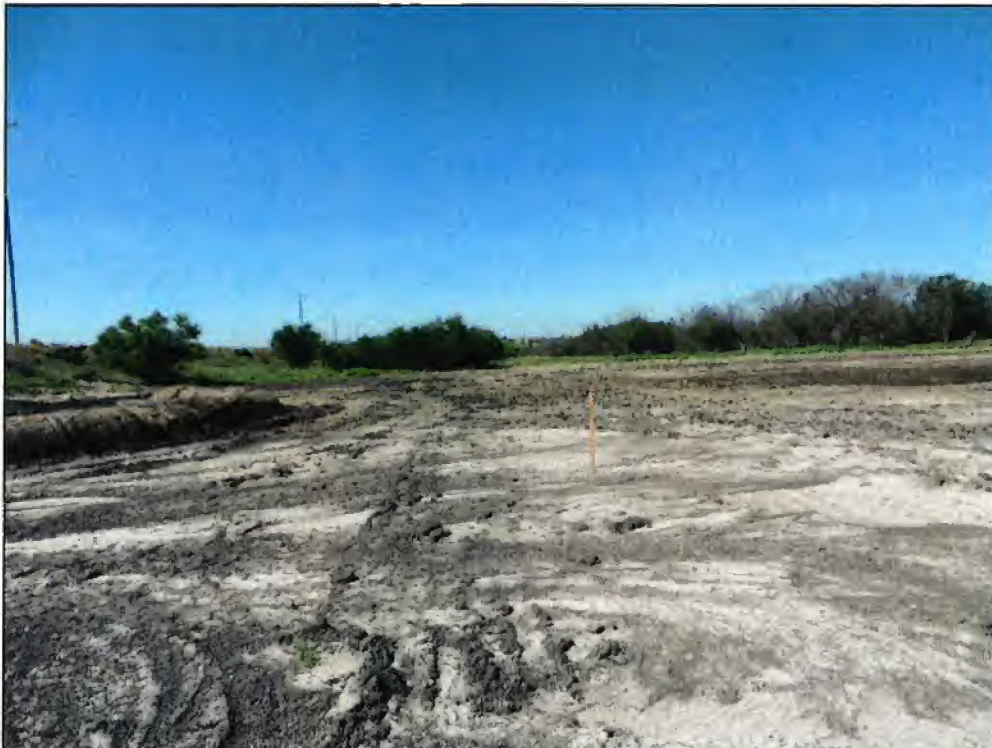
Photo 10. Affected area is now clear of vegetation and sediment (view southwest).

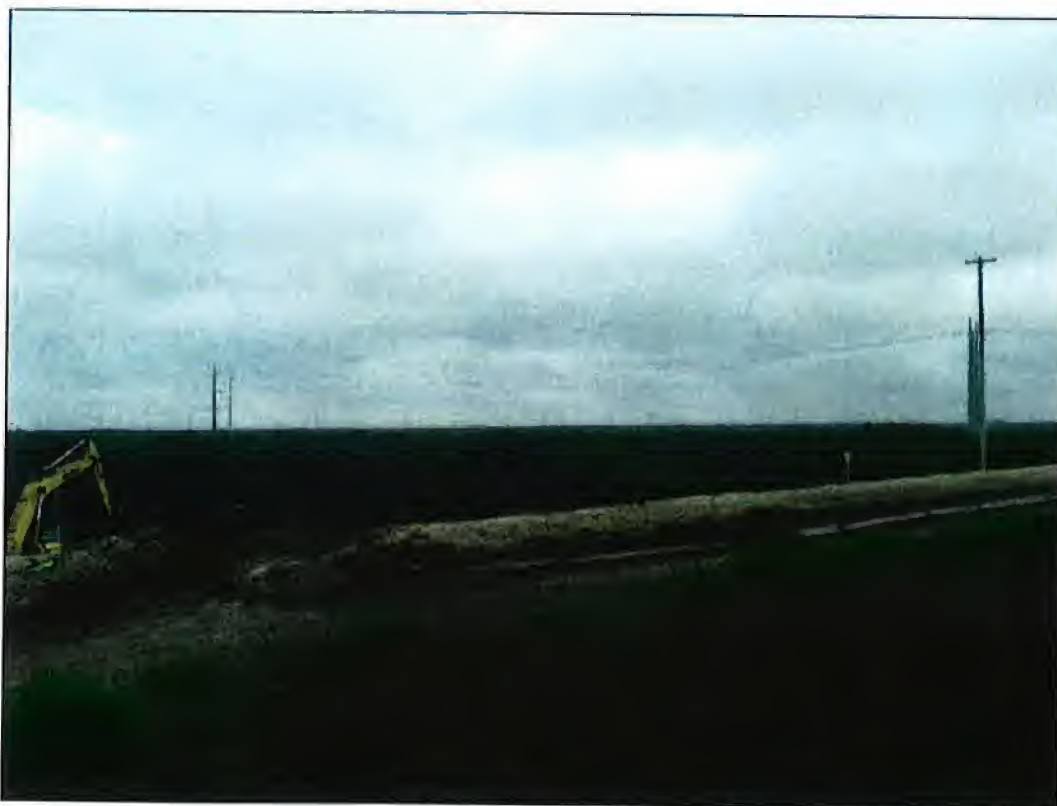
Photo 4. Area of disturbance from sediment located west of the main haul road (view northwest).

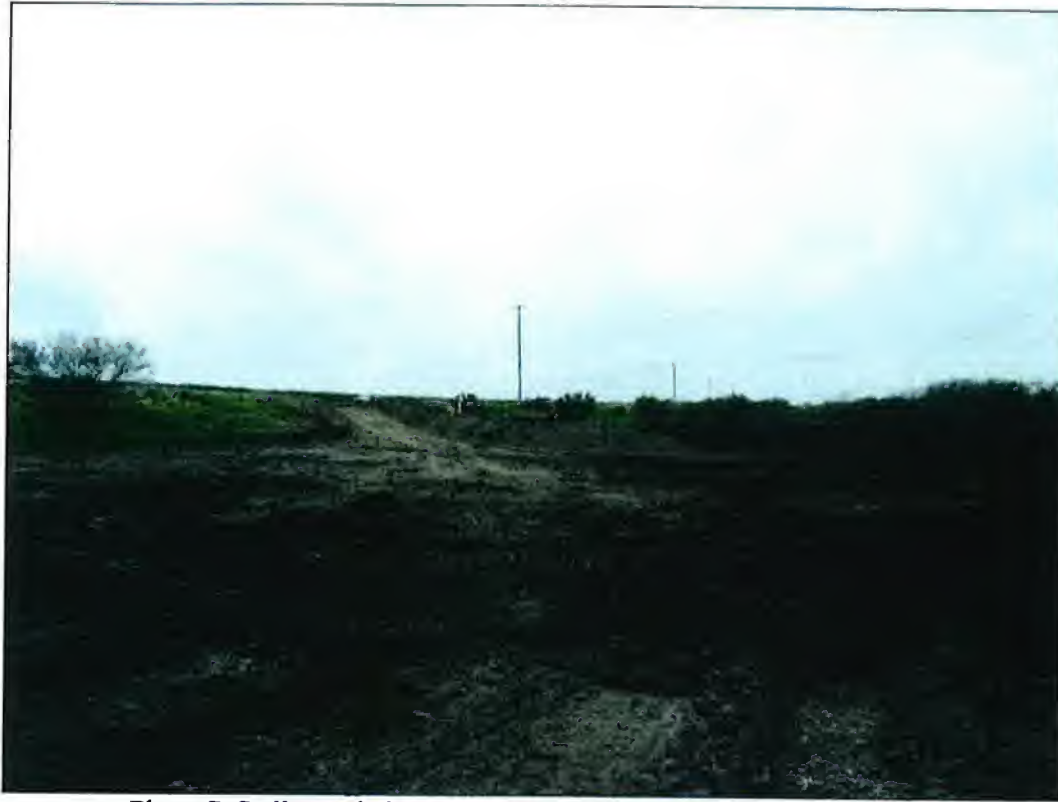
Photo 7. Sediment being removed from disturbed area (view south).

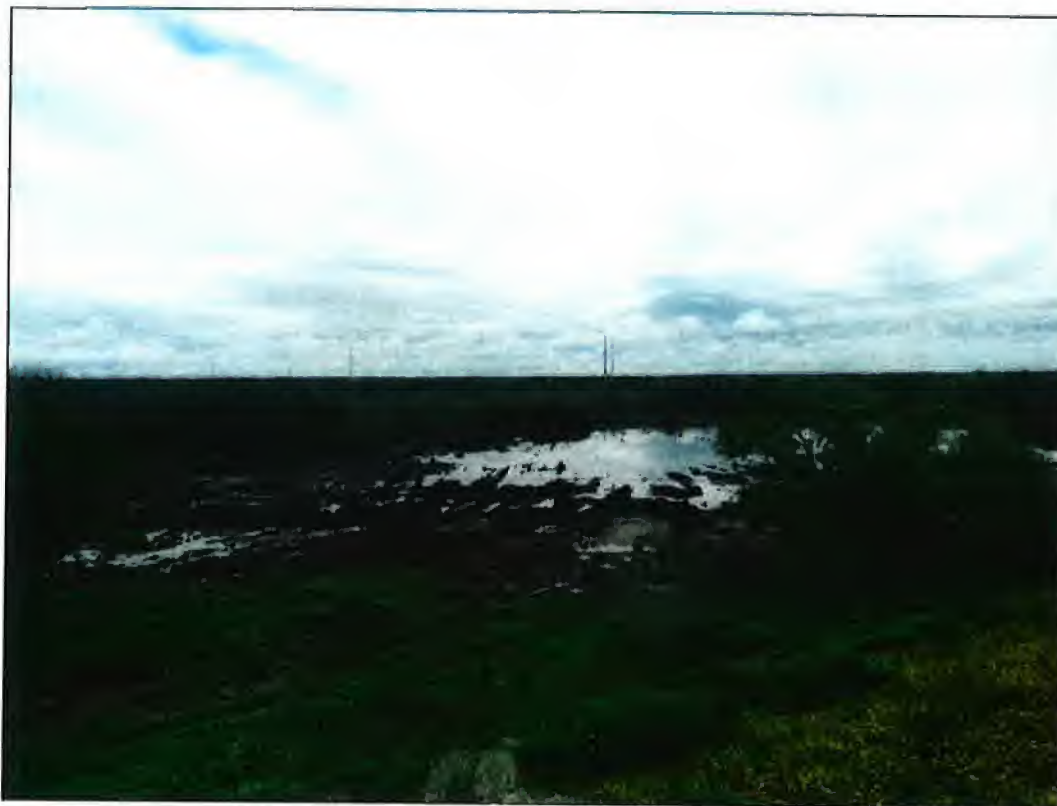
Photo 12. Disturbed area with waterlogged conditions of March 18, 2015 (view west).
